# Warm Roof Overlay: Citta Apartments Case Study

When a 105-unit residential complex in Auckland's CBD required a roof refurbishment, the Viking Roofspec WarmRoof system provided the solution - transforming a leaking, thermally inefficient roof into a high-performance assembly without displacing residents or generating landfill waste.

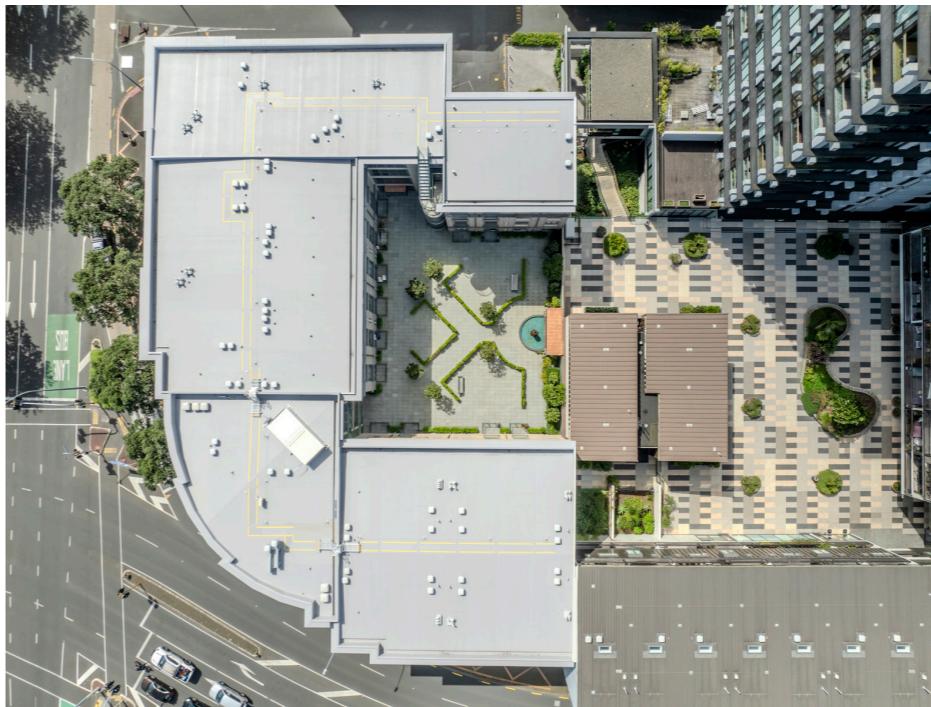
heat-welded Enviroclad walkway that rolls directly onto the membrane. This avoided penetrating the membrane while providing robust, grippy maintenance access.

This decision exemplifies experienced applicators adding value through system knowledge. Eliminating dozens of roof penetrations significantly reduced future maintenance requirements and leak risks over the system's 20-year-plus service life.
